DEVELOPMENT OF A PAVEMENT LIFE CYCLE ASSESSMENT TOOL FOR AIRFIELD
REHABILITATION STRATEGIES

THESIS

Submitted in partial fulfillment of the requirements
for the degree of Master of Science in Civil Engineering
in the Graduate College of the
University of Illinois at Urbana-Champaign, 2015

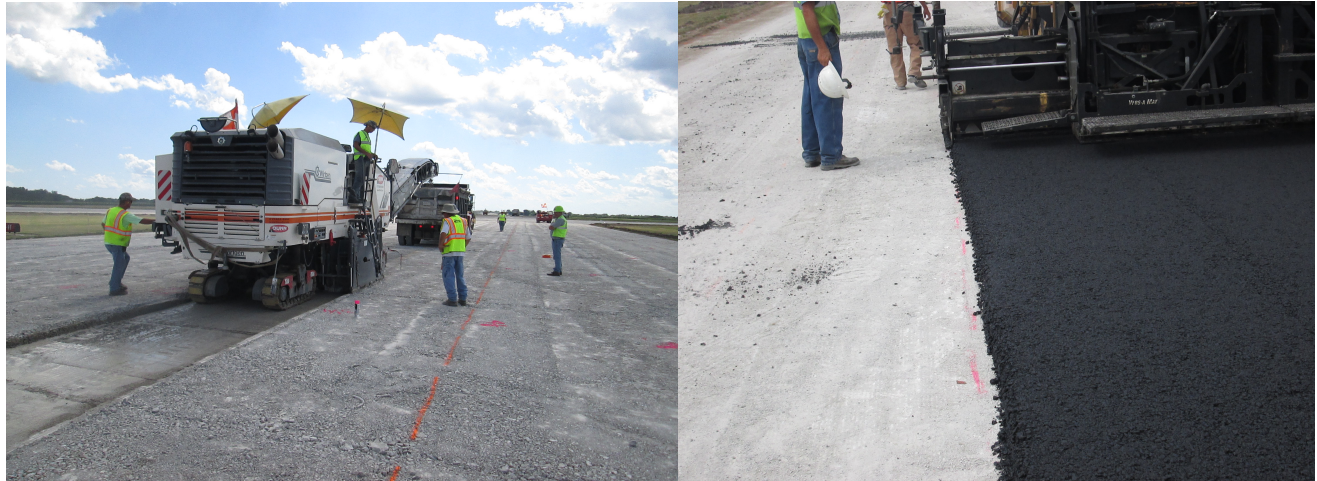
Figure 66 - Milling and Asphalt Paving at Coles County Airport - Charleston, IL
(Hanson Engineering, 2015)

More recently a rubblization with a mill/inlay with an AC overlay was conducted in July/August 2015 at Coles County Airport in Charleston, IL. The rubblized PCC was 14 inches over a 7-inch bituminous base layer. The constructed AC overlay was a minimum of four inches thick, with an average of five and a half as found by ground penetrating radar. The project called for milling in various locations to meet elevations of connecting taxiways. To accelerate the process and eliminate reflective cracking the project was modified and rubblization/milling was allowed. Figure 65 shows the guillotine breaker (dropped every 8-12 inches), the multi-head breaker and z-grid roller. The final product after each step is also seen. The test pit shows the effectiveness of the two-step breaking process. Figure 66 shows the milling and the subsequent overlay using a stringless paver. No issues were reported by the contractor and airport owner with this design and construction process.

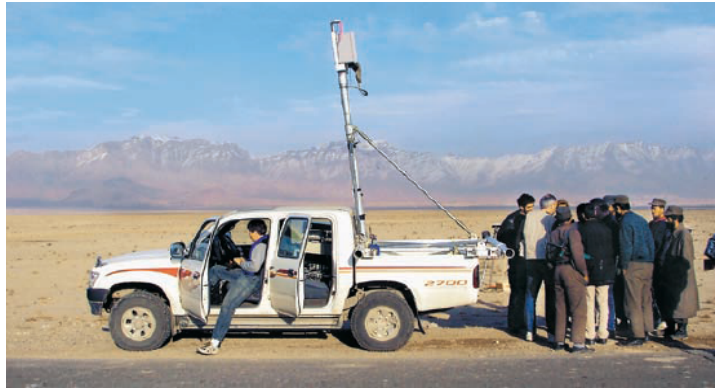
Figure 79 - Helicopter LIDAR Mounted to a Truck In Afghanistan
(Newby & Mrstik, 2005)

Advances have been made by placing cameras on vehicles but they initially lacked the 3D depth and coverage desired. In 2003 Terrapoint engineers introduced the first mobile LIDAR system. This was done in Afghanistan to map section of Highway 1 between Herat and Kandahar (~560 kilometers) to reduce the risk of enemy fire from surface to air munitions. The engineers mounted a helicopter LIDAR system to a truck as seen below in Figure 79. This solution worked well with a few limitations. The field of view was limited as the viewing angle is different from the air and from the ground. The view was only 60°, requiring multiple passes. The inertial measurement unit (IMU) was tactical grade requiring limited obstructions for accuracy. The system was mounted on a specific truck and therefore required modification to transfer between vehicles (Glennie, 2007). The value of the system was recognized and multiple commercial manufactures began to develop this technology. Figure 80 below, shows a current mobile LIDAR system. A paper by Yen, et. al. (2011) at the Advanced Highway Maintenance and Construction Technology Research Center discuss multiple models on the market (Yen, Akin, & al, 2011)

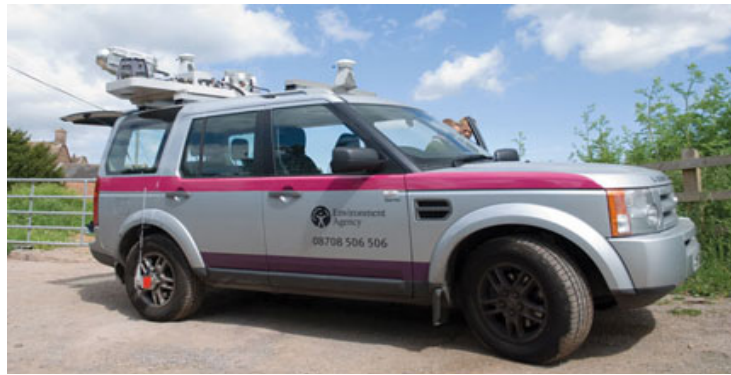
Figure 80 - Mobile LIDAR System
(Richman & Hogarth, 2010)

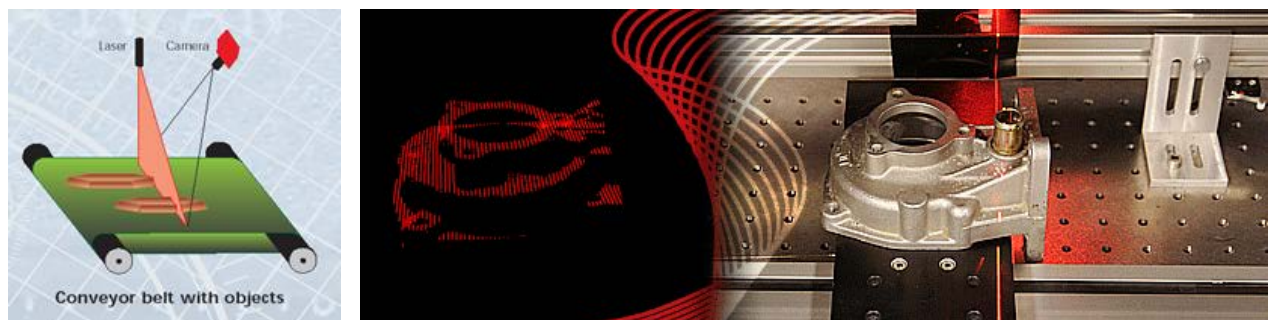
Figure 81 - Conveyor Belt 3D Imaging Based on Line Laser Scanning
(Adept Turnkey, 2015)

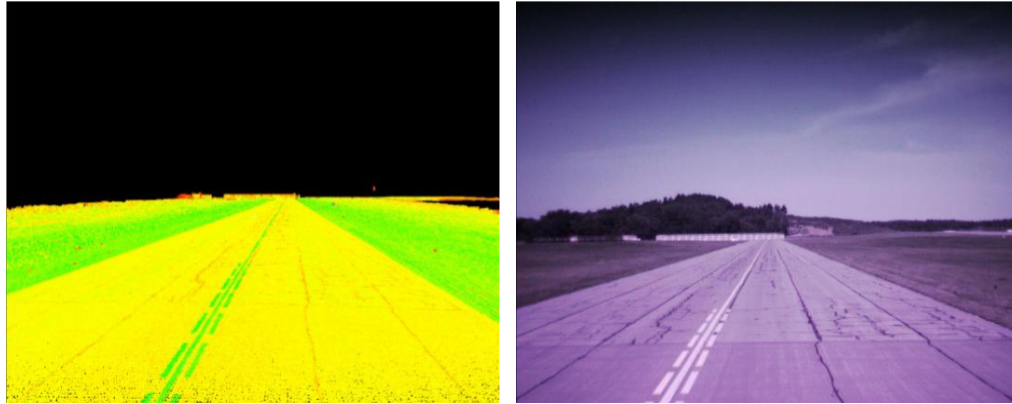
Figure 95 - (Left) LIDAR Point Cloud (Right) Digital Image
(Uddin, 2011)

Figure 95 below, shows the two types of data collected during an airfield survey; point cloud and a digital image. Both are necessary for effective post processing. Figure 96 below, shows a combined image for a LIDAR survey. The point cloud is processed and colorized to help with the visualization. Some distresses are difficult to see from just the point cloud, as maximum accuracy is one-quarter inch. Therefore, geo-referenced imagery is stitched together with the point cloud. At this point, algorithms can highlight or better define the edges of various airfield features as seen in green and blue. These algorithms can be used to create deliverables such as determine areas, quantities, etc. for different features. Laser scanning provides a higher quality image (1 mm resolution) even without digital images. Laser images are shown and discussed in depth below.

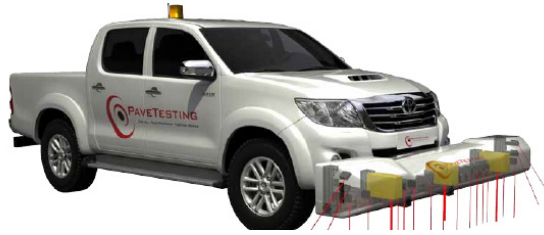
Figure 104 - Multi-Point Profiler
(PaveTesting, 2015)

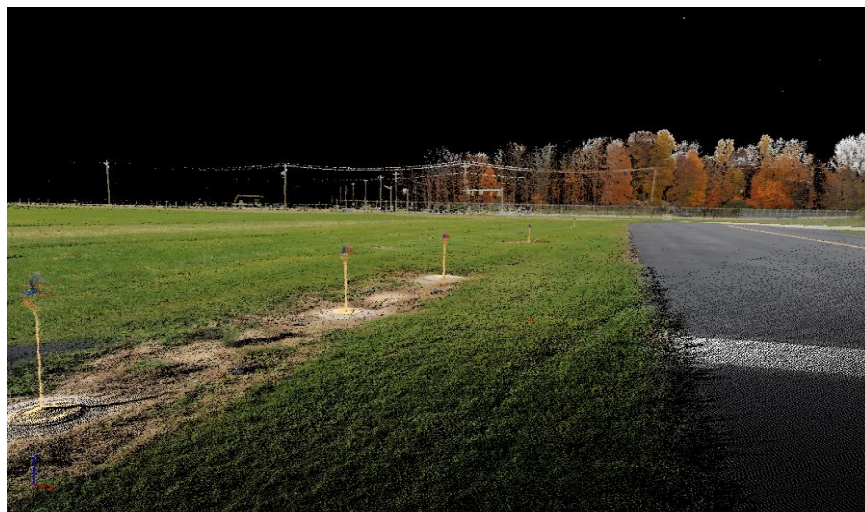
Figure 106 - LIDAR Point Cloud with Edge Lights Identified for Asset Management
(Risner, 2014)

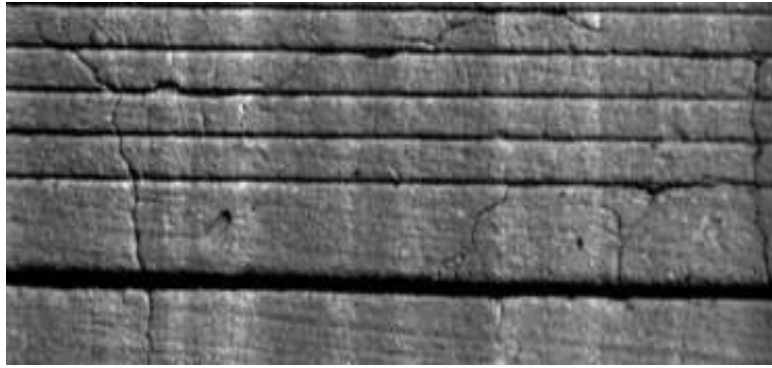
Figure 108 - Laser Scan of Runway 8R at Hartsfield Jackson Atlanta International Airport
(Wang & Hou, 2007)

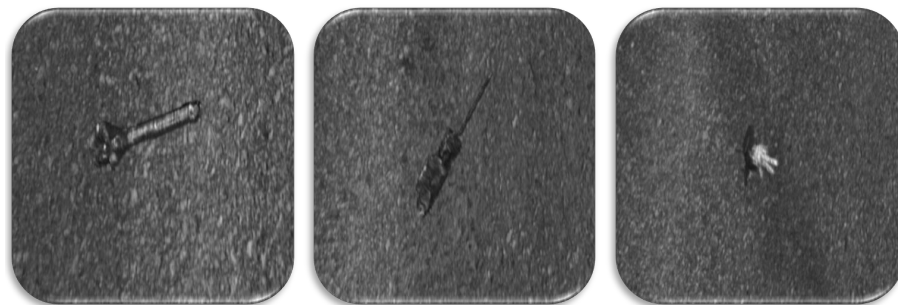
Figure 114 - FOD Detected via Laser Scans

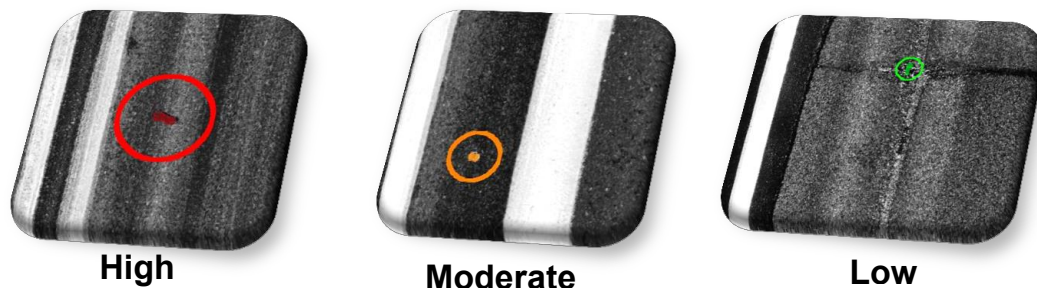
Figure 115 - FOD Severity Classification
(Fox & Laurent, 2013)

Pavemetrics Systems Inc. has developed a FOD detection system. The user inputs the height and area parameters and drives the vehicle on the pavement. Any object exceeding the parameters is identified. It's exact location and image is recorded as seen below in Figure 114. Based on parameters, the program will also classify the FOD severity as high, medium or low as seen below in Figure 115. In a single pass, the operator can look on the edges of the pavement while the scanners cover most of the aircraft wheel path areas in a single pass when the pavement is busy. At night or during a slow period, a more comprehensive scan with the lasers can be accomplished. This system can assist in rapid assessment and removal of FOD and reduce possible FOD incidents.

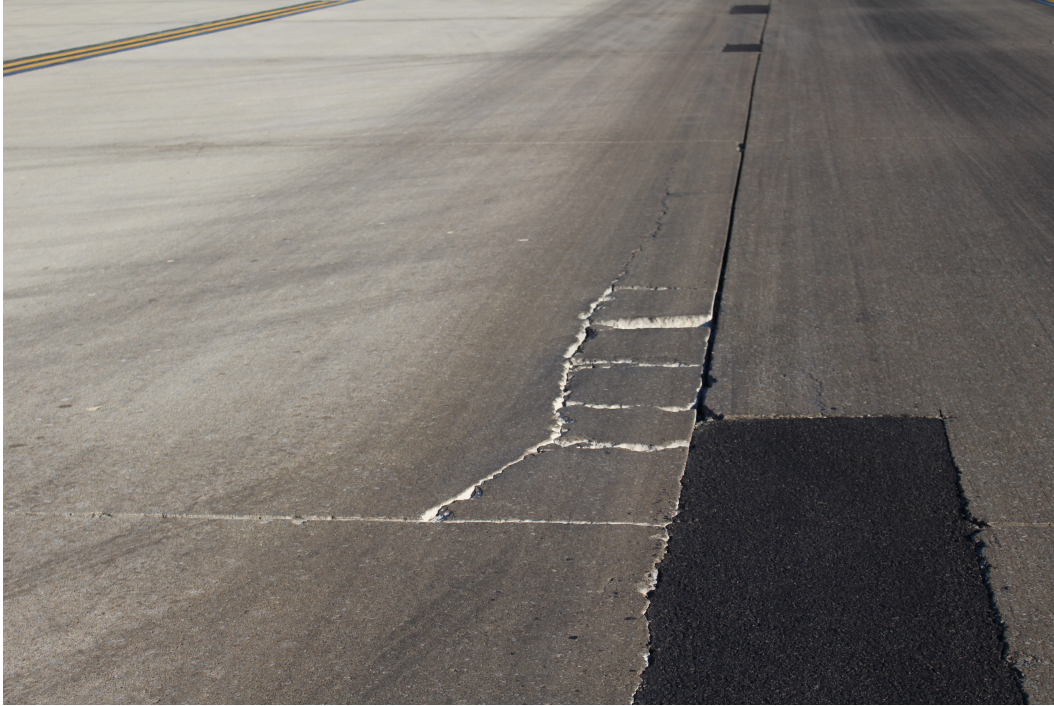
Figure 116 - Longitudinal Cracking at Joint and Patching

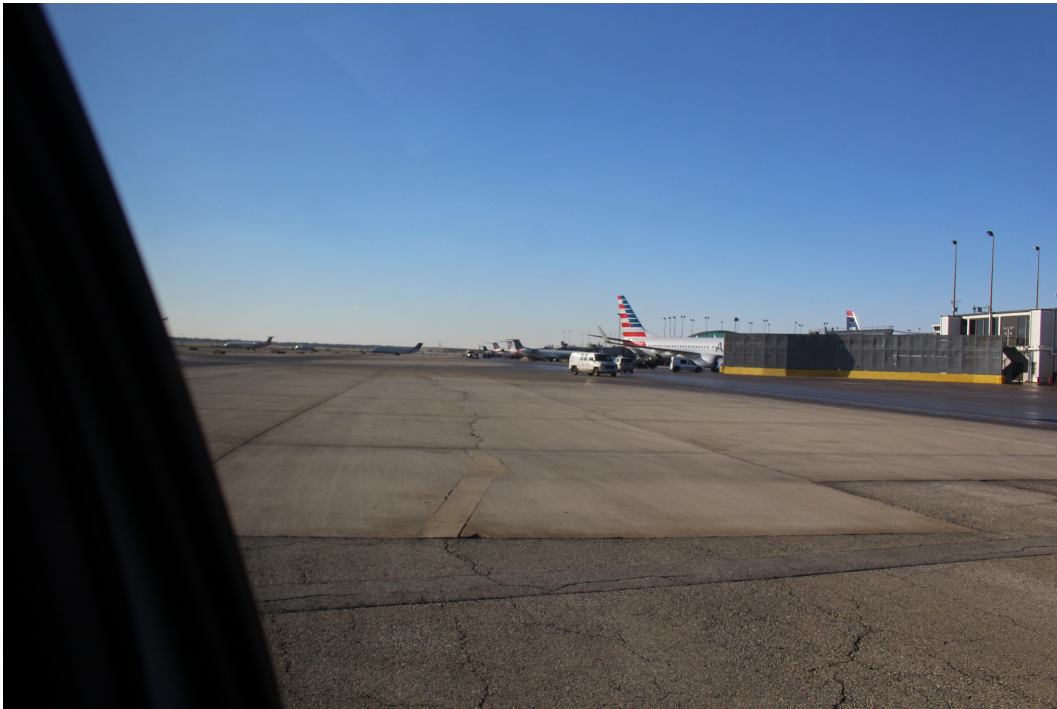
Figure 117 - Longitudinal Cracking (PCC) and Fatigue Cracking (Asphalt Inlay)

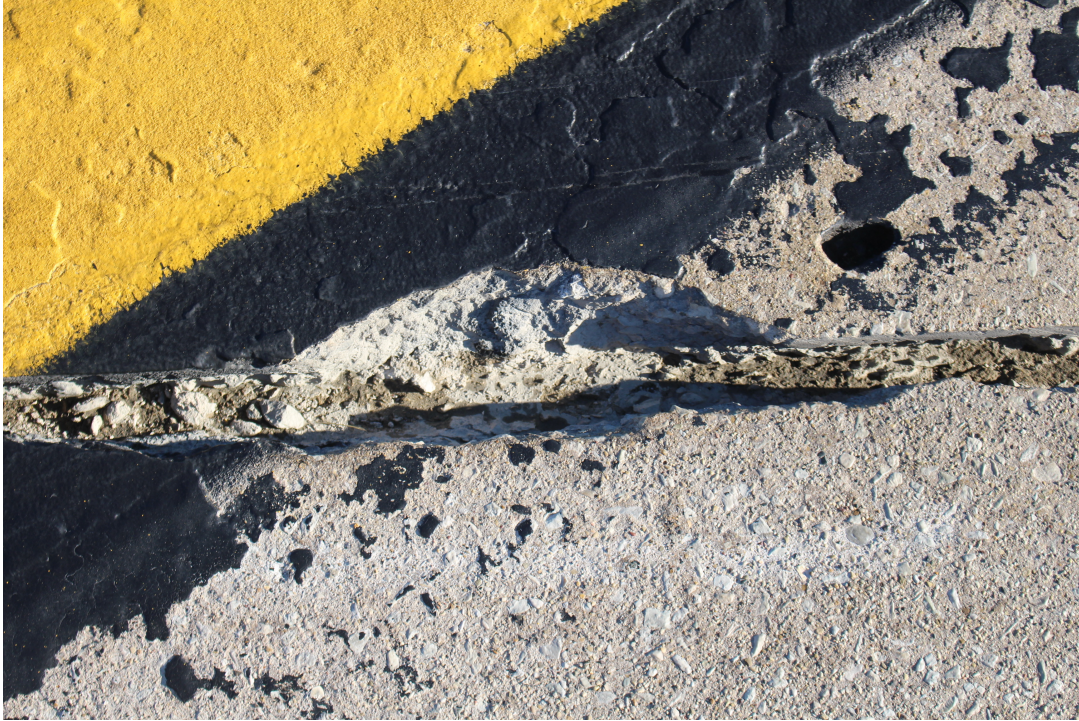
Figure 118 - Joint Deterioration

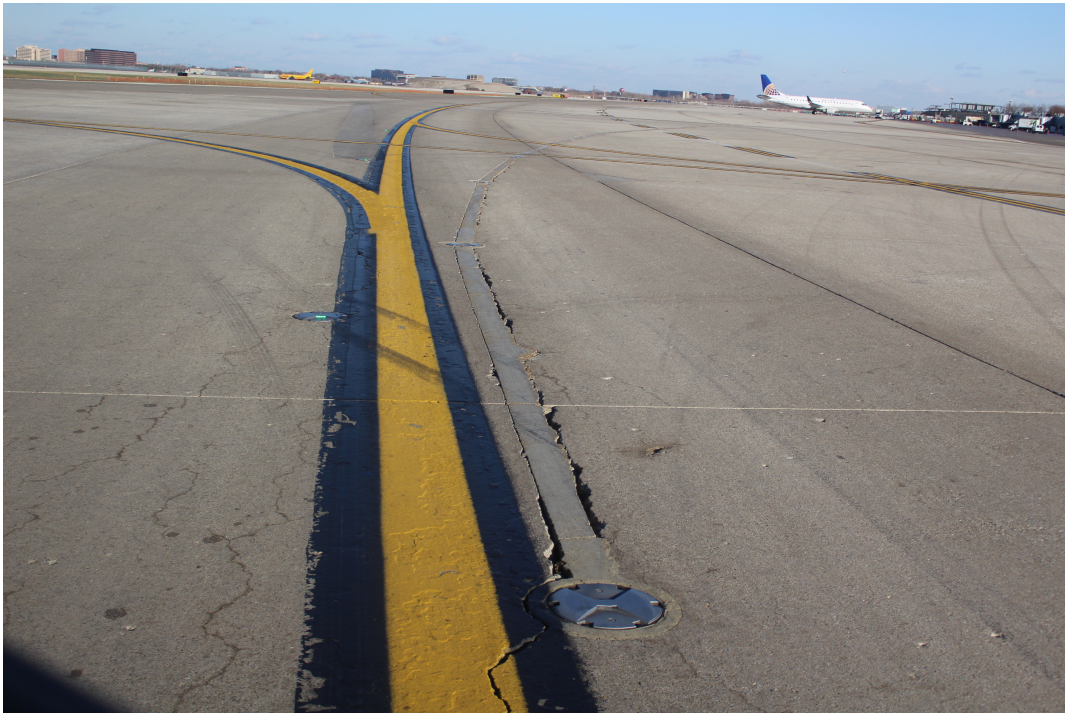
Figure 119 - Material Compatibility and Deterioration

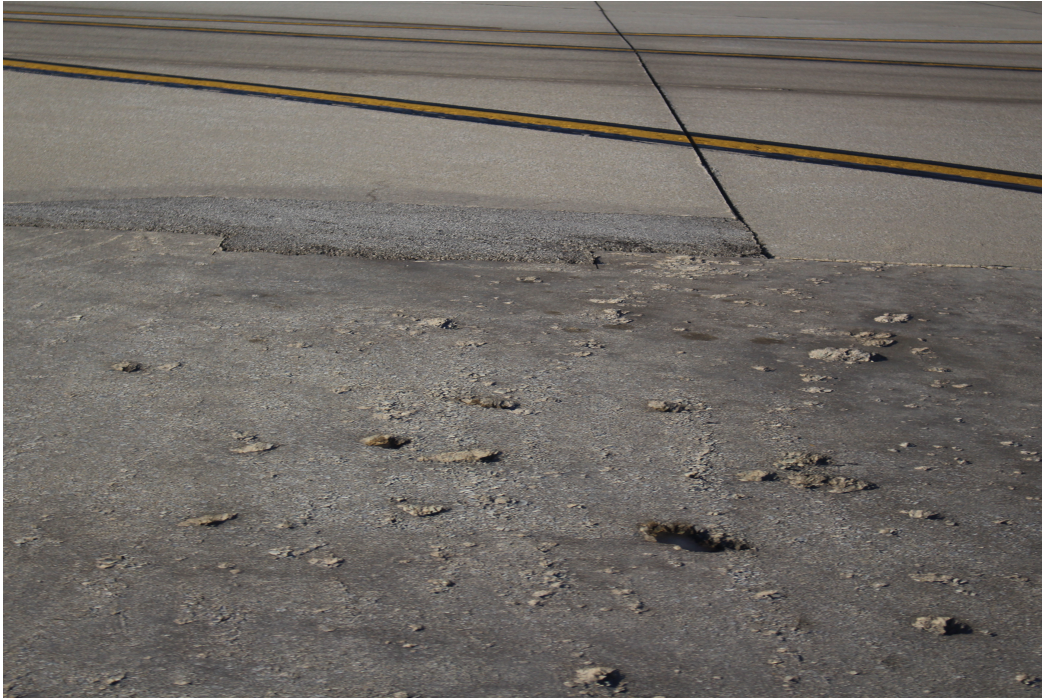
Figure 120 - Freeze/Thaw Damage (Pop-outs)
